WOODHAM WALTER

CONSERVATION AREA CHARACTER STATEMENT

This document was produced by Maldon District Council.

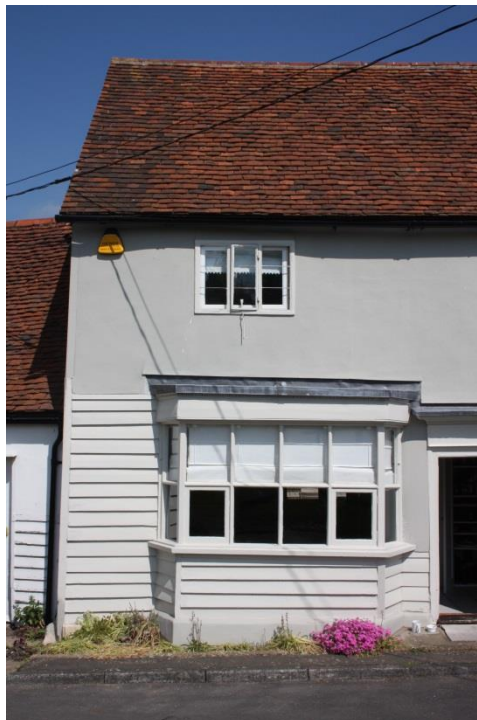
Fig. 1 Render above weatherboarding on Wingtons

Around half the buildings in the conservation area are **rendered**. Normally the render is applied to a timber frame. A few of the modern houses have render applied to masonry. The earliest example of render over brickwork is probably Lynton House (1888), which has exposed brickwork quoining framing the rendered panels. There are also fragments of a plaster finish on the 16th century brickwork of the parish church. Wingtons has smooth render with a gently undulating surface arising from the movement of the timber frame over the centuries. Nos1 & 2 The Maples retain their Edwardian un-painted pebbledash render.

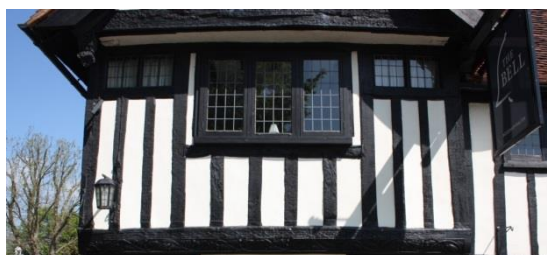
Fig. 2 Exposed timber framing on The Bell

1930s to re-expose the timber frame. The studs are closely spaced in the East Anglian tradition known as “close studding” (fig. 2). In the mid-20th century Wendover Cottage had black-painted battens applied to its rendered finish in imitation of the half-timbered appearance of The Bell. More recently, the small extension added to the south side of the parish church in 2014 has an exposed oak frame in-between which there are vertical oak planks and battens, all left unpainted and allowed to silver over time (fig.3).

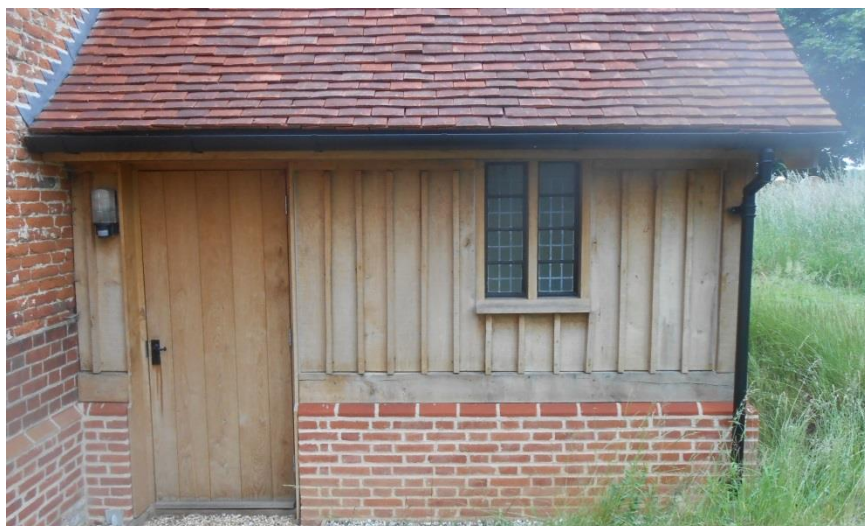
Fig. 3 Un-painted oak cladding on the recent extension to the parish church

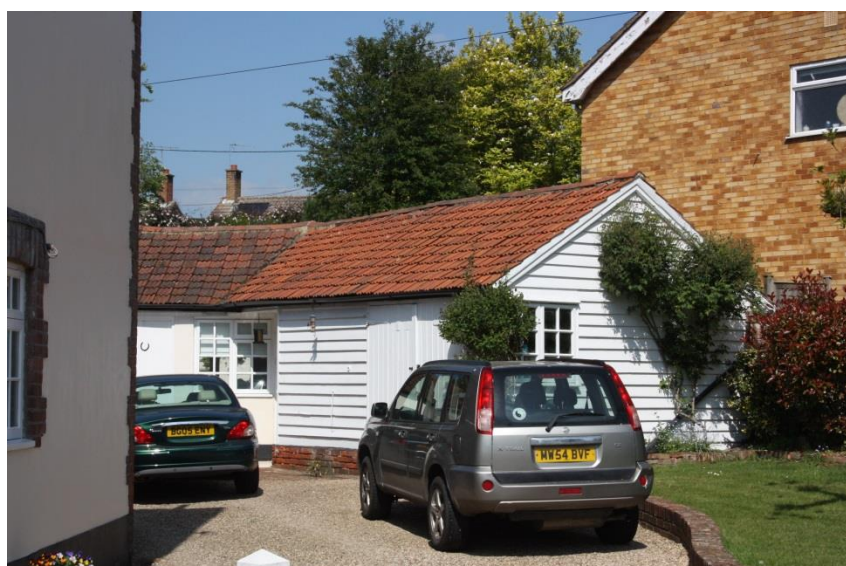
Fig. 4 White painted weatherboarding at Lynton

A more common type of timber cladding is horizontal, featheredged **weatherboarding**, normally painted black or white. This is a distinctly vernacular material which features on many rural historic houses in the Maldon District. The most notable example in the village is probably Tadpoles Nursery (the former Congregational Chapel built in 1881). It is also found on Wingtons on the flank wall and along the bottom of the front wall. It is often found on outbuildings such as the former stables at The Bell and Lynton and on the former privies to the rear of the almshouses. Black painted weatherboarding is used to good effect on the late 20th-century extension to Ferndale.

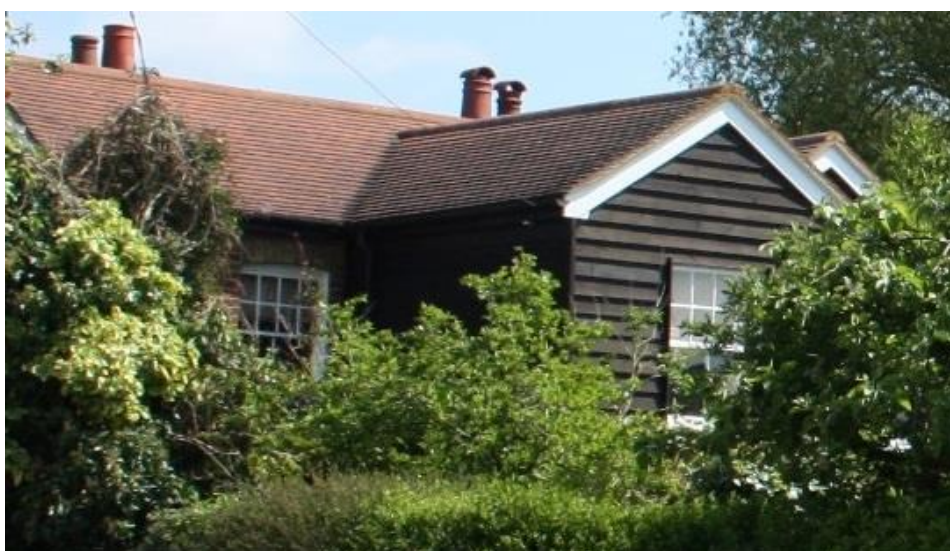
Fig. 5 Black painted weatherboarding at Ferndale

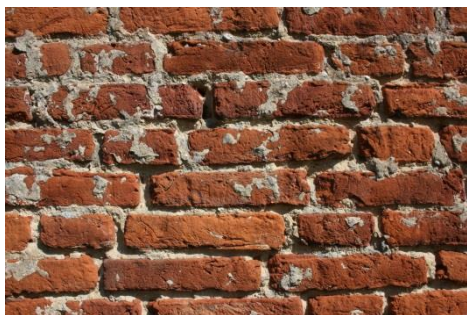
Fig. 6 Brickwork on the parish church (1562-4)

The oldest **brickwork** in the conservation area is found on the parish church (fig. 6); an important example of Elizabethan brick architecture with delightful crow-stepped gables. It is not until the middle of the 19th century that whole houses are found built of brick (i.e. Lynton House, Redbrick Cottage and Ferndale). The use of red brick embellished with contrasting yellow or white brick banding occurs to good effect on the school and at Ferndale (fig. 7).

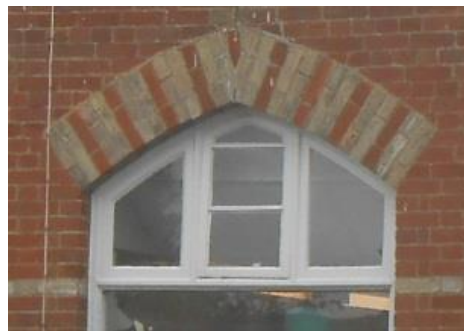
Fig. 7 Brickwork on the primary school (1873)

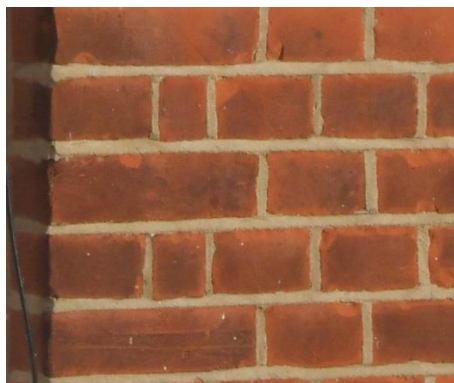
Fig. 8 Brickwork on the almshouses (1908)

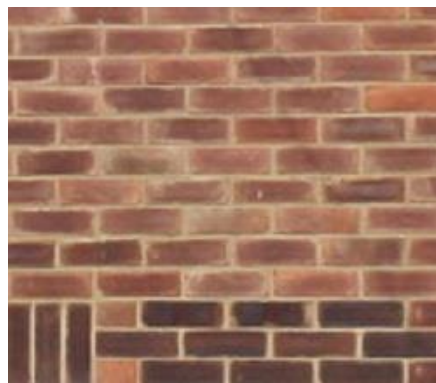
Fig. 9 Brickwork on a house of the third quarter of the 20th century

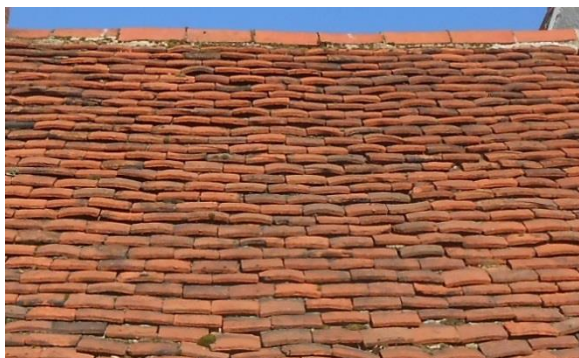
Fig. 10 Double-cambered clay plain tiles

The oldest buildings in the village are roofed with handmade **clay plain tiles** laid steeply (47° to 50°). Ranging from deep orange to brown in colour, these old tiles have a textured and slightly irregular surface and a double-cambered profile (fig.10). Such tiled roofs are an important component of the special character of the area. The outbuildings to the rear of Lynton House and at the northern end of Ash Cottage are covered by distinctive orange clay single-lap **pantiles** (fig. 11).

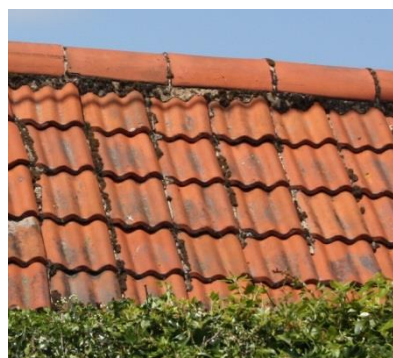
Fig. 11 Single-lap clay pantiles

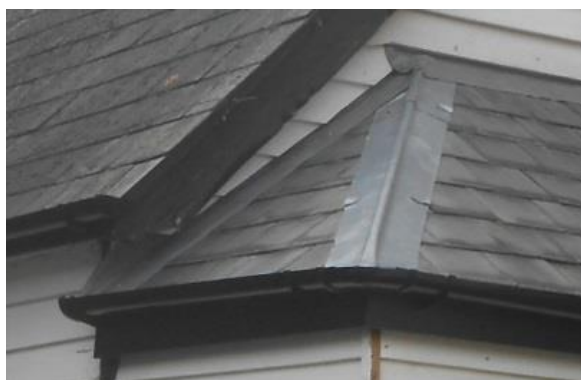
Fig. 12 Natural slate

Welsh **slate** was being imported to Maldon by sea from the 18th century and it became increasingly popular throughout the district in the 19th century. It is found on several of the mid-late 19th century buildings in the village, which tend to have slacker roof pitches as a consequence (typically 35° to 40°). Slate is also used to good effect on the recent extension to the school, where it reflects the roof covering on the Victorian building.

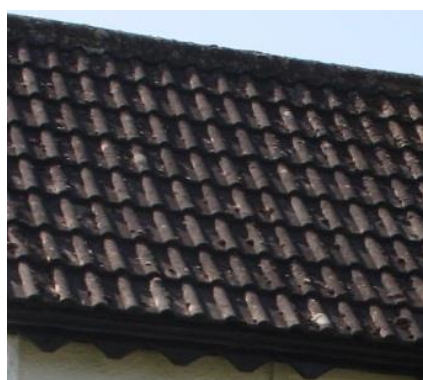
Fig. 13 20th-century concrete tiles

Brown **concrete tiles** are quite common in the village, notably on most of the mid-late 20th century houses. Their dull brown colour lacks the warmth of the older clay tiles. They have sadly also been used to replace the original roof coverings of some of the 19th-century buildings such as Church Cottage and the Queen Victoria pub, and detract from the traditional appearance of these properties as a consequence. The reinstatement of more traditional roof coverings on the older properties in the village, if and when the opportunity arises, would be positively encouraged.

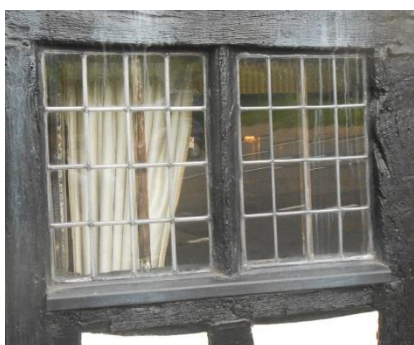
Fig. 14 Early 17th-century mullion window

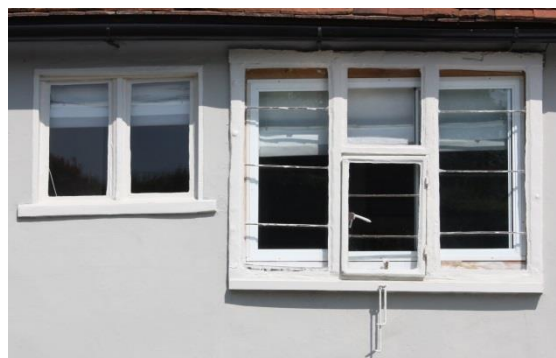
Fig. 15 Early 17th-century mullion window to left of 18th-century casement window

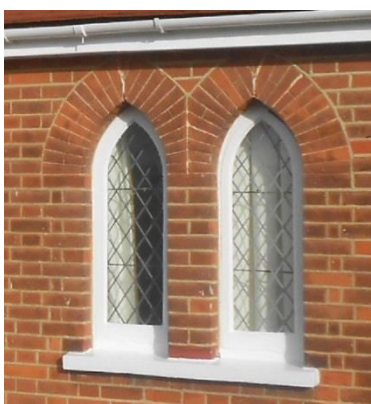
Fig. 16 Early 20th-century lead-glazed windows with pointed arch heads

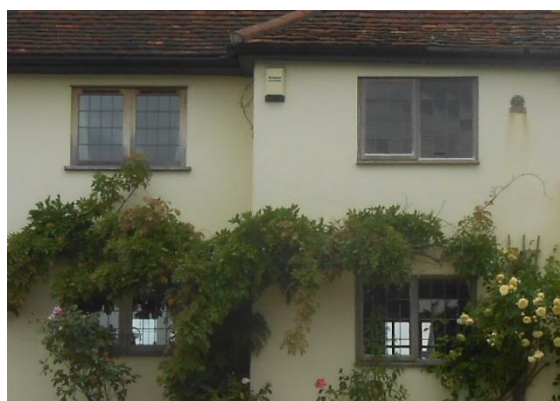
Fig. 17 Lead-glazed windows in unpainted oak frames

There are a wide range of window types and dates throughout the village. Lead-glazed windows, and vernacular windows which were originally lead glazed, are a notably common feature of the village, although all the lead glazing itself appears to date from the 20th century. The oldest windows in the village are the early 17th-century ovolo moulded mullion windows in The Bell which were uncovered and restored in the 1930s (fig. 14). Wingtons also has one small and easily overlooked moulded mullion window of the 17th century on the first floor of its front elevation (fig. 15). To the right of this there is a vernacular flat-framed casement window dating from the 18th century. Although now plain glazed, the horizontal saddle bars reveal that it originally had lead-glazed panels. Bannister Cottage has similar casement windows which were originally lead glazed. Later examples of lead glazing are found in the almshouses where they are housed in brick gothic arched openings (fig. 16), in the extension to the south of the church and in Fort Cottage where the 20th century window frames are of unpainted oak (fig. 17).

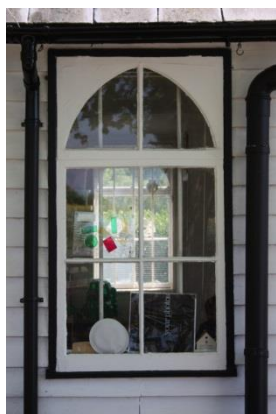
Fig. 18 Arch headed casement window

Some of the painted timber windows at Tadpoles Nursery (fig. 18) have arched heads in reference to the original ecclesiastical function of the building. The bay windows at the east end of The Bell and the west end of Wingtons probably relate to the former presence of shops in these parts of the properties. Casement windows with asymmetrical fanlights replaced the sash windows in the Queen Victoria pub in the 1960's, considerably eroding this building's traditional character in the process. Vertically sliding sash windows dating from the 19th and early 20th centuries are relatively common and attractive features. More unusual is the horizontally sliding sash on the front elevation of Wingtons (fig. 19). Where plastic windows have been inserted they generally fail to replicate the traditional detailing and appearance of painted timber sash windows, demonstrated by a comparison of 1&2 The Maples (fig. 20). But the modern green-finished metal windows on the extension to the school prove that contemporary-style fenestration can appear sympathetic on new buildings in historic areas (fig. 48).

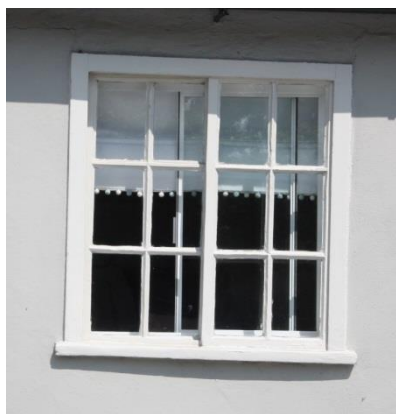
Fig. 19 Horizontally sliding 'Yorkshire' sash

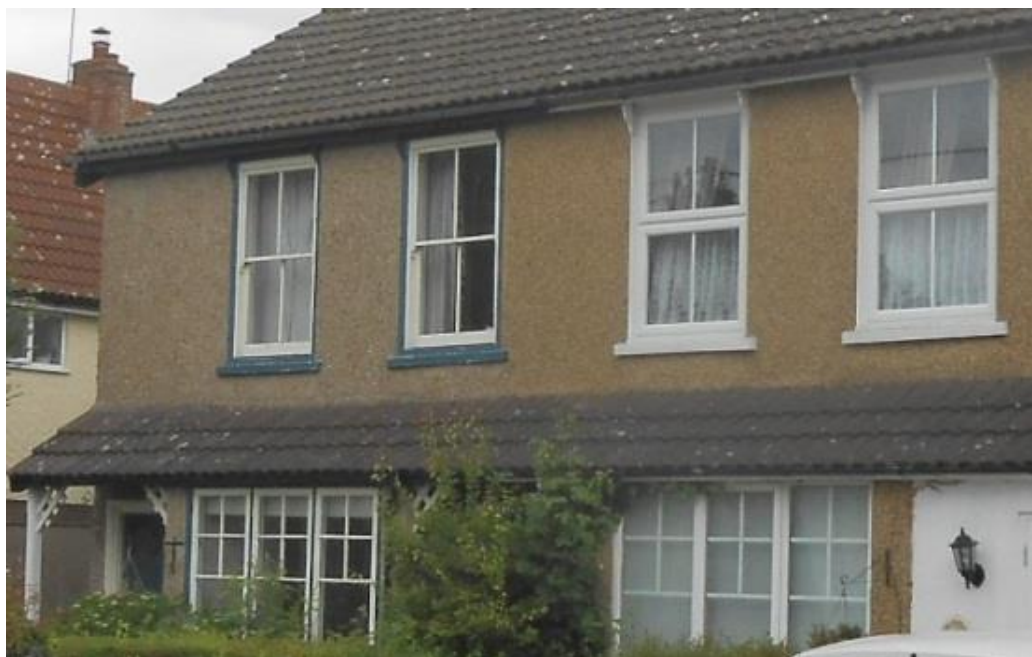
Fig. 20 Original painted timber windows and plastic replacement windows

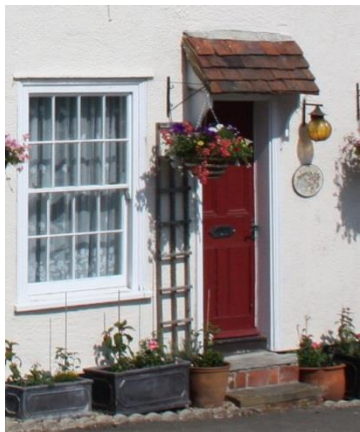
Fig. 21 Four-panelled door

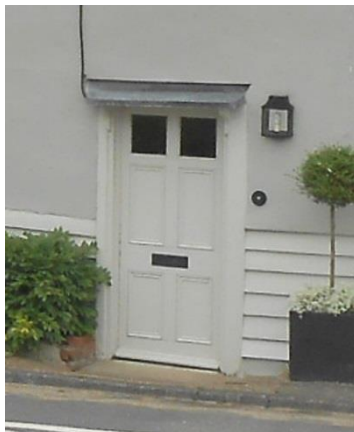
Fig. 22 Six-panelled door

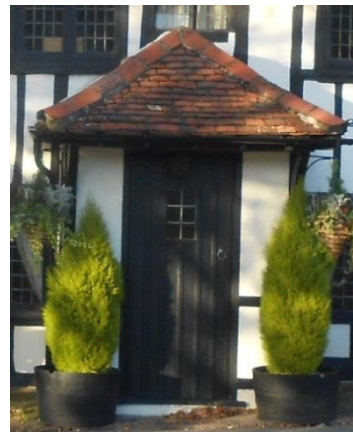
Fig. 23 Timber door with vertical batten stained black

Doors are generally less prominent features than windows in the conservation area but there are good quality examples of historic and modern timber doors. Notable historic doors include the front door on Bannister Cottage, which is of a traditional four-panel design (fig. 21), and the front door of Wingtons, which is of six panels with the upper two glazed (fig. 22). Sympathetic 20th-century doors include those on the front of The Bell and the unpainted oak door on the front of Severn house (fig. 23).

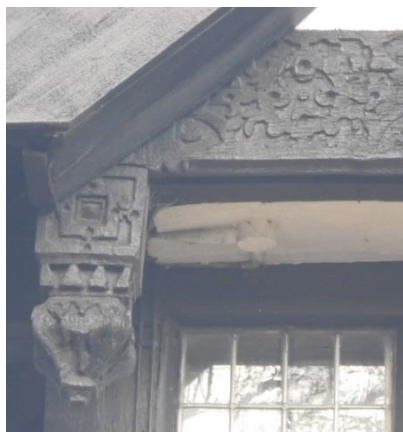
Fig. 24 Strapwork carved decoration

External decoration is very limited but of special note is the original carved decoration on The Bell. The gable bressummer was carved with a renaissance strapwork design with pendants of a similar style hanging from each end (fig. 24). This decoration helps date the building to the early-17th century. The first-floor jetty bressummer is carved with a band of interlocking ovals and lozenges above a band of oak leaves and acorns (see front cover), the latter perhaps in reference to the wooded character of the village. There are also ornamental terracotta blocks in the top of the gable to Lynton House. These blocks, primarily in the form of floral and foliate motifs including sunflowers, were highly popular in the 1870s and 80s.

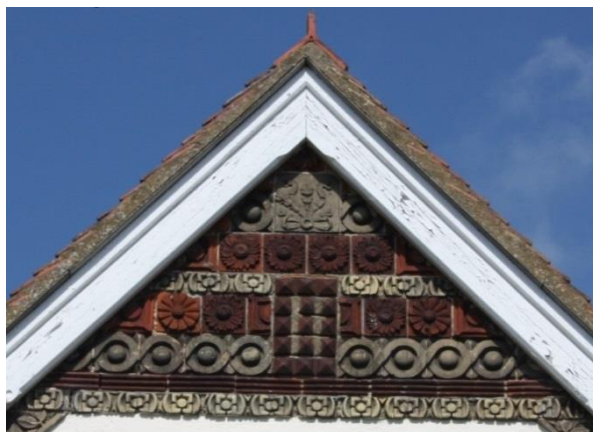
Fig. 25 Ornamental terracotta blocks

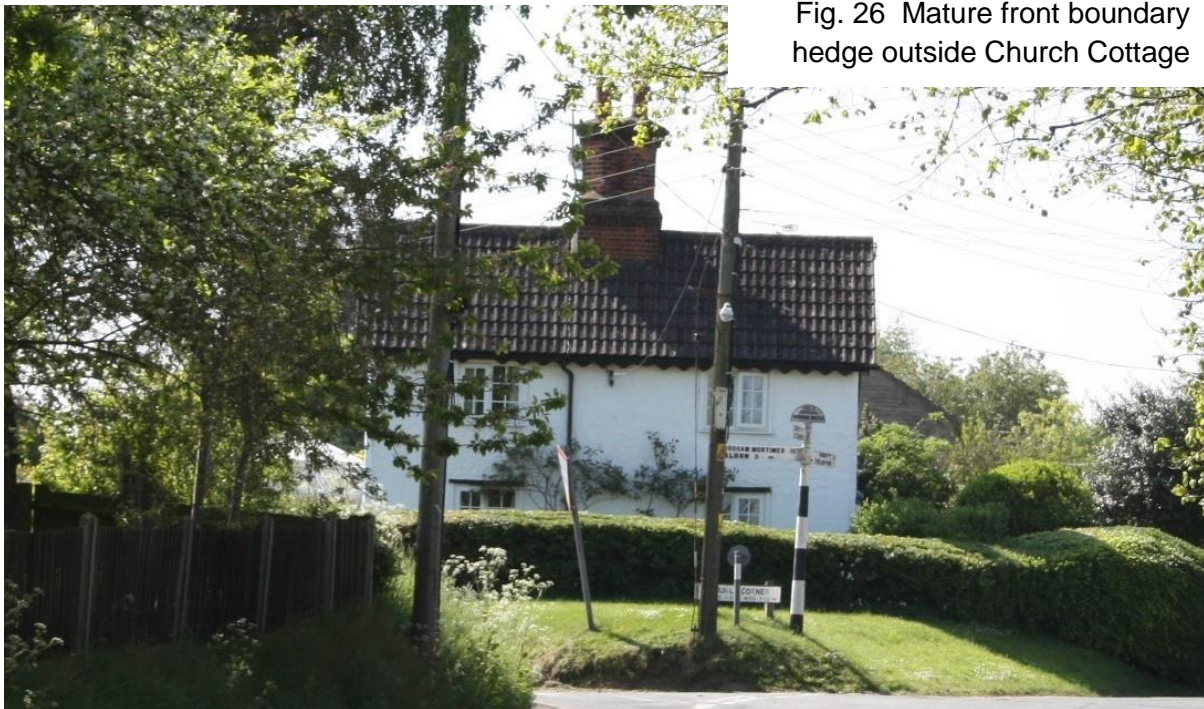
Fig. 26 Mature front boundary hedge outside Church Cottage

Boundary treatments are an important form of townscape enclosure, and their quality has a considerable impact upon the character of the area. Woodham Walter is notable for some good traditional boundary treatments. A number of properties have mature front hedgerows which can make houses appear to nestle into their plots, and contributes to an Arcadian character. Such hedgerows complement the setting of traditional properties such as Church Cottage and 2 The Maples, but can also soften the presence of more modern buildings and the clutter of parked cars as at Bandoola and Coppers.

Situated at the southern extremity of the conservation area, **Church Cottage** was first built in the Victorian period as a pair of cottages and was converted into a single dwelling in the 20th century. The house occupies the triangle of land at the junction of Church Hill, Herbage Park Road and Oak Farm Road. The plot is raised above road level making the building appear prominently in the streetscene, despite its relatively modest scale. The building's best feature is a bold 17th-century style red-brick chimney stack comprising four grouped lozenge-section shafts and moulded caps and base. The cottage is a full 2 storeys at the front, dropping to 1 ½ storeys to the rear under a catslide roof. Certain modern alterations – such as the brown concrete roof tiles, the uPVC windows and uPVC conservatory – detract from its traditional character. But the silhouette of the building remains striking and attractive and is complemented by the mature hedge along its front boundary and the oak trees to the south-west of it.

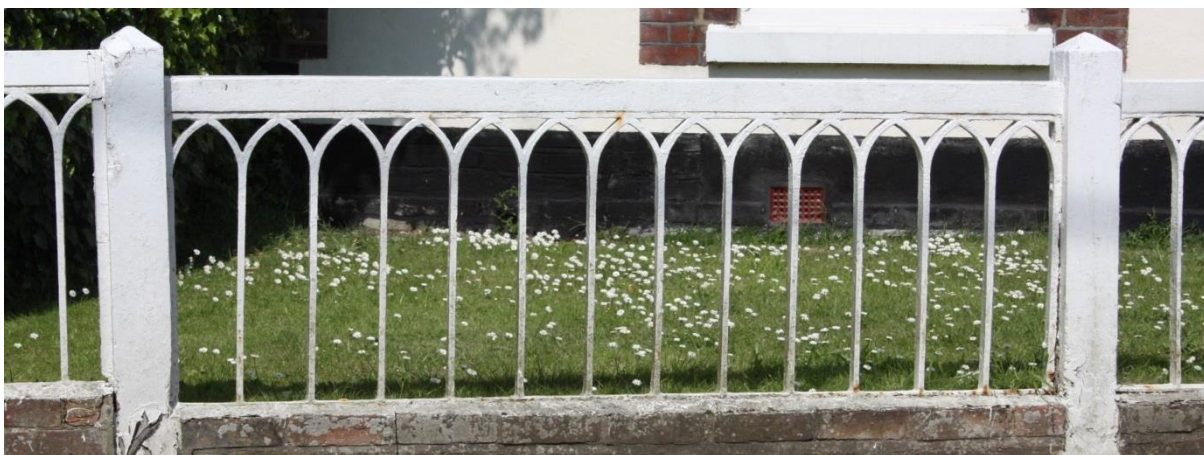
Fig. 27 Front railings outside Lynton House

The front fence is of an unusual, but charming, design comprising wooden post and rails surrounding iron balustrades that intersect in pointed arches (fig. 27). Attached to the rear of the house are structures which, early in the 20th century, were used as a flour store and bakery. Flanking the northern side of the driveway is an attractive former stable building clad in weatherboarding and roofed in Roman clay tiles (fig. 4).

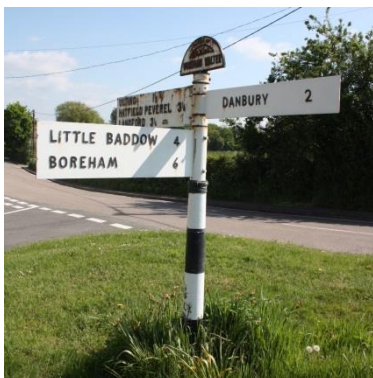
Fig. 30 Cast-iron fingerpost opposite The Bell

There are several examples of traditional street furniture within the conservation area which make a positive contribution to the special character of the village. As with the historic buildings, these are features which merit sympathetic maintenance and retention. Of particular note are two black and white painted cast iron **fingerposts** made by Maldon Ironworks in the first quarter of the 20th century. One is in front of Church Cottage on the junction between Church Hill and Oak Farm Road, and the other is opposite The Bell on the junction between Church Hill and Little Baddow Road (fig. 30). There are several good traditional **benches**, the best being two green painted wrought-iron benches with scroll shaped arm rests, one on Bell Meadow and another inside the bus shelter (fig. 31). A plaque inside the **bus shelter** explains that it was erected in the late 1940s by the British Legion of Woodham Walter as a war memorial. The shelter's modern brickwork is softened by the ivy growing up its front at the time of the survey. The red painted **phone box** and **post box**, situated in front of Tadpoles Nursery, are attractive and familiar features in the village scene, located at a focal point of the village in close proximity to the School, The Queen Victoria pub and the bus shelter (fig. 32).

The junction between Church Hill and Little Baddow Road is a highly attractive and memorable space, enclosed by picturesque old houses to the north and the steeply sloping Bell Meadow to the south. It is a triangular space with an island of grass in the centre which hosts a black and white painted fingerpost manufactured by Maldon Ironworks; an important historic feature in its own right. On the north side of the junction, The Bell, Wingtons and Bannister Cottage (each described in more detail below) comprise one of the most winsome groups of historic buildings in the Maldon District. The oak tree immediately to the south-west of The Bell is a notably valuable element in the composition; framing views of the historic buildings and at certain times of day filtering dappled sunlight onto The Bell.

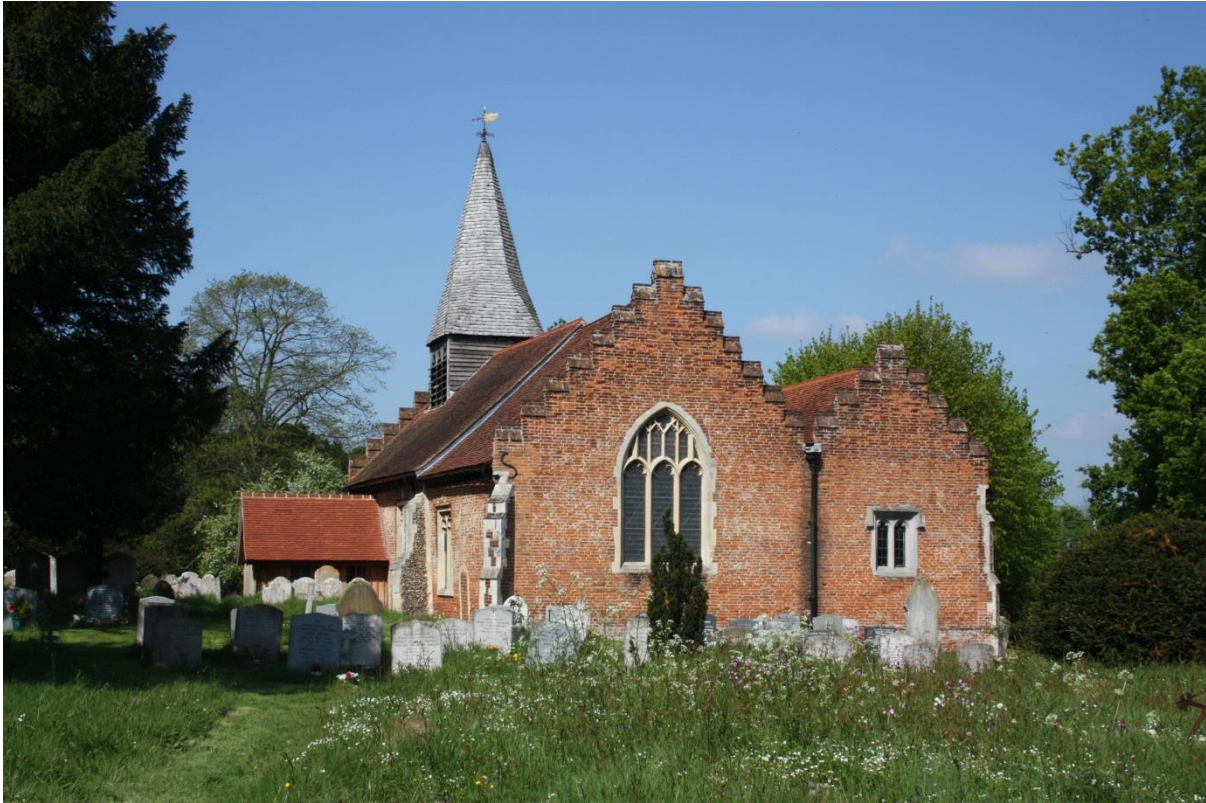
Fig. 33 The parish church view from the east

The Parish Church of St Michael is the most important historic building within the boundary of the conservation area. A grade II* listed building, the church is historically notable for being the only church in Essex to be built during the reign of Elizabeth the first. It was constructed in 1562-3 and consecrated in 1564. Its medieval predecessor is thought to have been located close to the site of Woodham Walter Hall $\frac{1}{2}$ a mile to the south east. The church is quite small in scale, constructed primarily of soft red bricks with crow-stepped gables and a bellcote topped by a shingle clad spire. Interestingly for the date, the windows are all still perpendicular gothic in style. Some of the windows may originally have been recycled from the medieval church, although they now appear to be Victorian replacements. A small extension, employing high quality traditional materials, was added to the south side of the church in 2014. The extension, designed by Gerald Barret and built by Robbie Wilks, is similar in form to a long lost porch which used to occupy the same position and which features in an 18th-century drawing. The architectural features and history of the church are described in greater detail elsewhere and need not be reiterated here (i.e. the list description, Pevsner and Ryan)

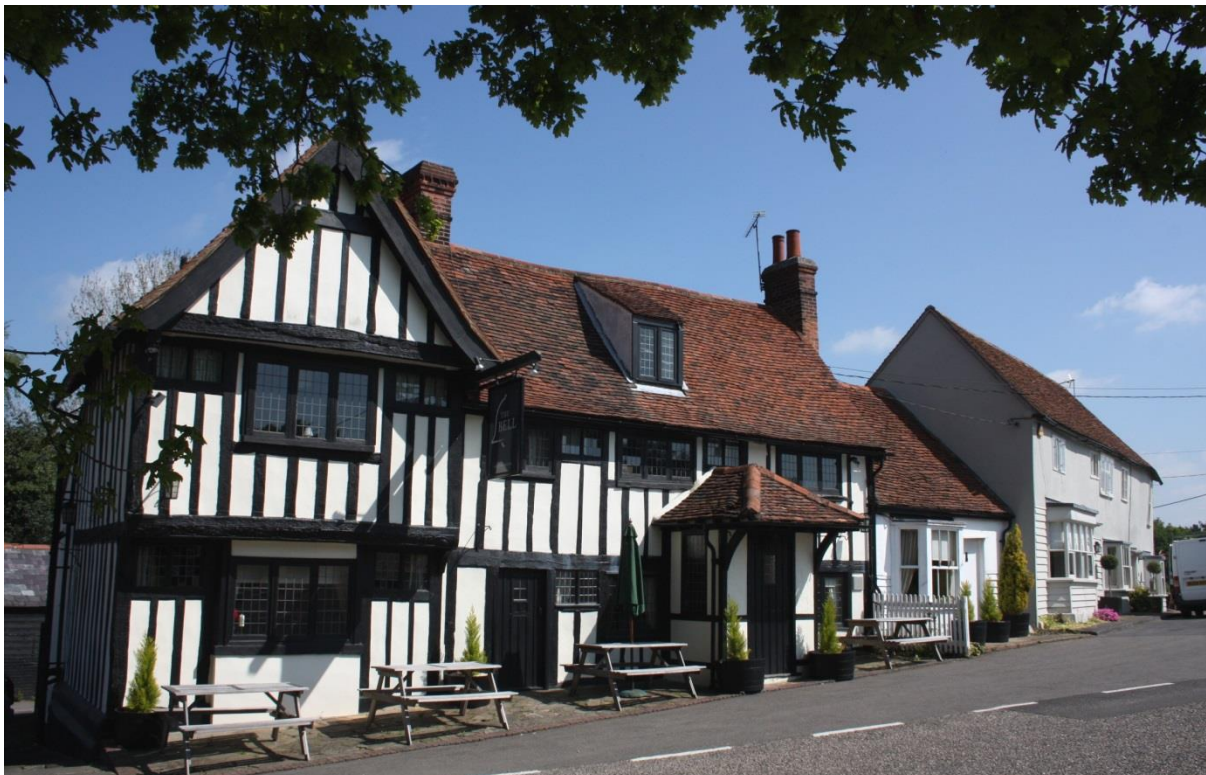
Fig. 37 The Bell

Apart from the parish church, **The Bell** is the most significant historic building in the conservation area. It is grade II listed, although such is its architectural quality that arguably it could merit upgrading to II*. Its construction, layout and decoration all indicate it was built early in the 17th century. Around 1930 the southern and western elevations were restored to their original appearance with a commendable degree of accuracy. The building's close-studded timber-framed construction was re-exposed and lead-glazed windows were reinstated. The exposed timbers have been painted black, as was fashionable early in the 20th century but was probably not the finish in the 17th century. It was (and still is) quite a showy building, with most of the finances thrown at the front elevation which has carved decoration and almost continuous glazing. Notably there is no evidence of any original windows on the other elevations.

The most elaborate part of the building is the crosswing, at the left-hand end, which has a jettied first floor and a jettied gable. As described above (see p. 13), the crosswing has lavish carved decoration. The central windows on the crosswing originally projected as an oriel and bay. Many of the smaller windows retain their original mullions. The single-storey Georgian eastern extension was occupied by a shoemaker's workshop in the 19th century (Ryan, p. 84). The continued use of the building as a pub makes a valuable contribution to the vitality and character of the village.

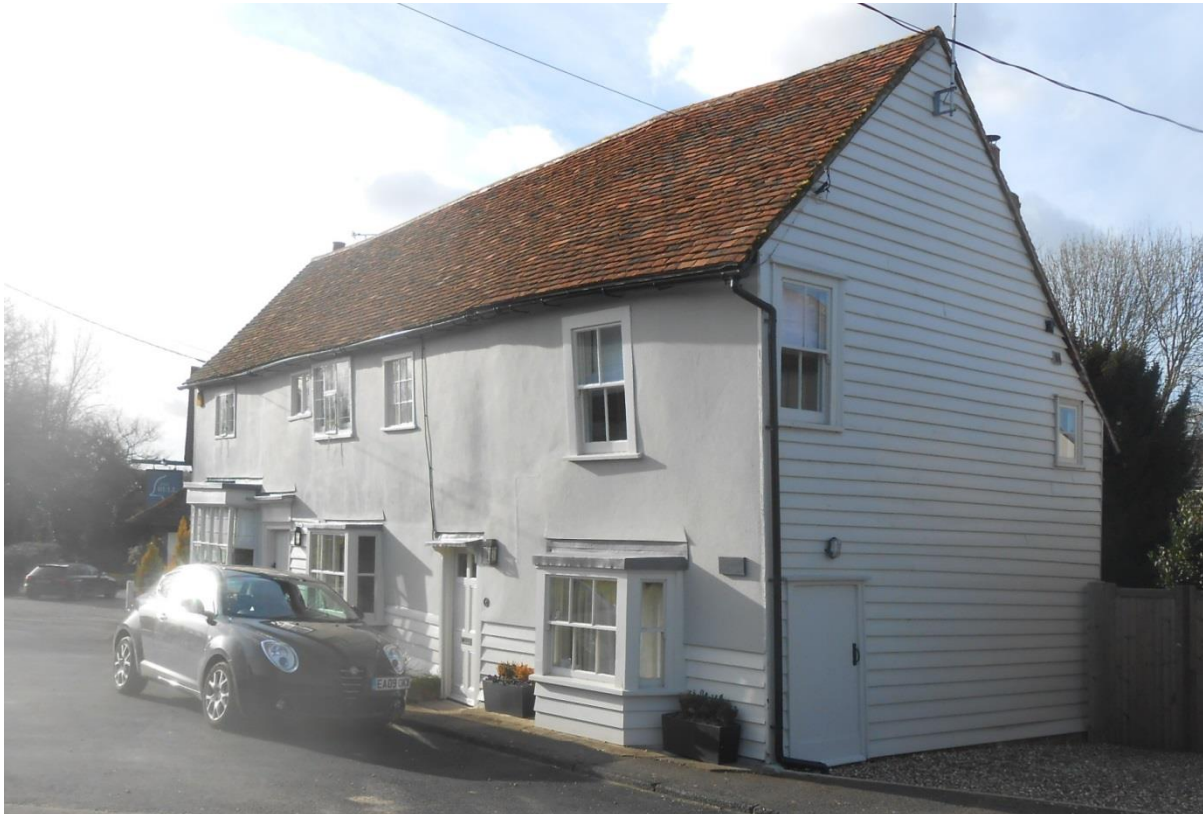
Fig. 38 Wingtons

It is not obvious from the outside, but **Wingtons** (listed grade II) also dates from the 17th century, albeit from a little later in that century than The Bell. On the front elevation there is a small first-floor window with a moulded mullion (second from left) which is original, and there are features inside the building which confirm the 17th-century date. However, unlike The Bell, the charm of Wingtons derives less from its original features, than from the way in which it has been adapted organically over the centuries in a vernacular fashion. There are windows on the front elevation dating from the 17th, 18th, 19th and 20th centuries, and no two are the same! On the ground floor there are three bay windows. In addition to vertically sliding sash windows, there is one horizontally sliding sash (also known as a Yorkshire sash), and two wonderful Georgian casement windows of a type which has rarely survived in the Maldon District.

The upper parts of the front elevation are rendered and the lower parts are clad in weatherboarding, but the junctions between these two types of cladding are at variable levels. The eastern flank is clad in weatherboarding. According to Pat Ryan: “The property was leased by Thomas and Hannah Shynn, shopkeepers who first appeared in the parish registers in 1731. All the rooms listed in James Brown’s inventory of 1794 can be identified in the house as it stands today” (Ryan, p. 91).

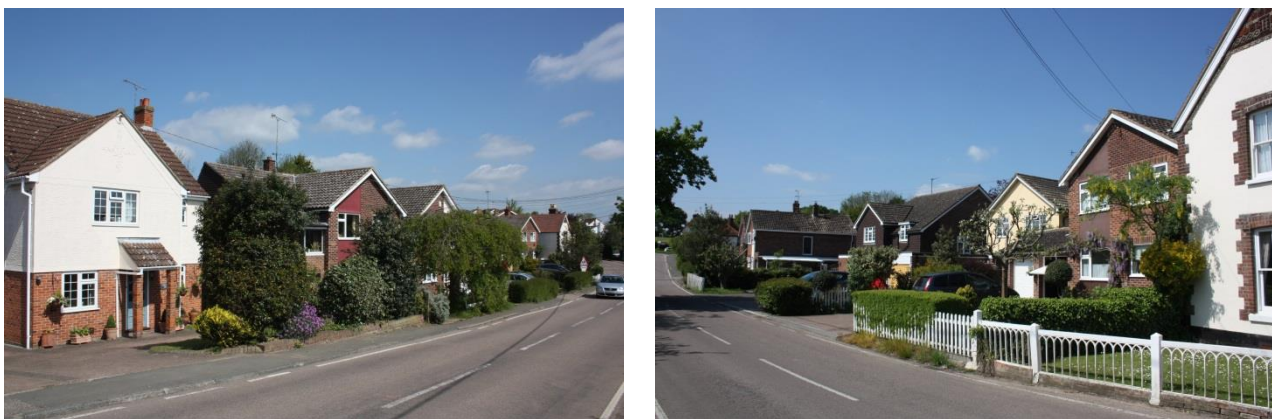
Fig. 40 Modern houses on the west side of The Street between Bannister Cottage and Lynton House

Between Bannister Cottage and Lynton House there are six modern houses built from the 1960s onwards. From south to north these are **Thenneck Burn, Dobbins, Bandoola, Brookside Colt House, and Coopers**. These houses are typical of their date and make a neutral contribution to the special character of the conservation area. The houses are set back further from the Street than the older houses, and their modern appearance is softened by some well-established trees and hedges.

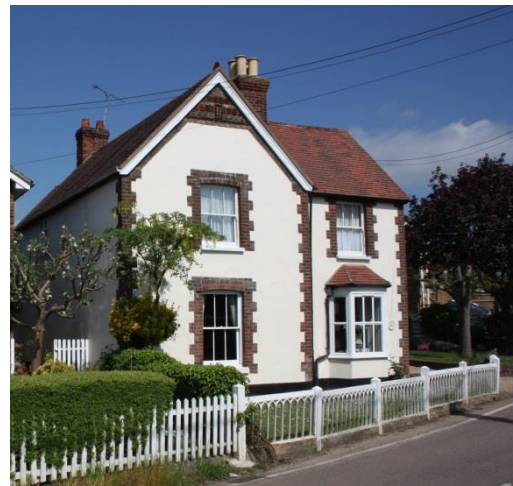
Fig. 41 Lynton House early in the 20th century (left) and in 2016 (right)

Lynton House is a late-Victorian brick property comprising a gabled crosswing to the left and a narrow 'hall' range to the right. The building is rendered except at the corners of the walls and around the windows, where the brickwork is exposed and arranged in the fashion of masonry quoins, creating quite a distinctive appearance. The gable to the crosswing is embellished with ornamental terracotta blocks primarily in the form of floral and foliate motifs including sunflowers. The original front door and porch, which feature in old photographs, have been removed and a doorway which once existed on the flank of the 'hall' range has been converted into a window. But the frontage is otherwise little altered.

A study of the 19th century OS maps indicates that this property was built between 1881 and 1896. Apparently there is a date of 1888 inscribed in the rear gable of the original house, now concealed within the roof of the flour-store extension.

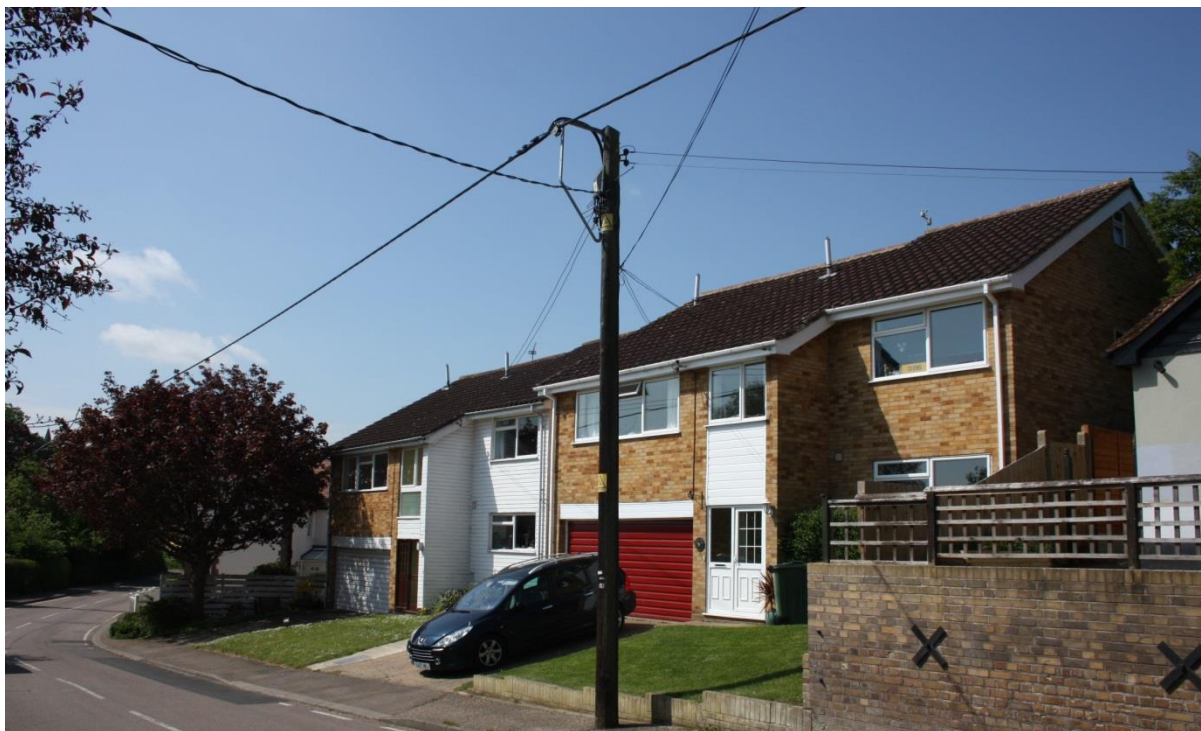
Fig. 42 Lares and Robin Hill

To the north of Lynton are **Lares** and **Robin Hill**. These are two detached houses built at the same time in the 1970s, each incorporating an integral garage. They are constructed of yellow brick and roofed in brown concrete rooftile. On each house the right-hand end of the front elevation is stepped back and rises to taller eaves. The two houses are typical of the period and make a neutral contribution to the special character of the conservation area. They are quite prominent due to the way in which the land rises up from The Street. Lares has a pleasant Maple tree in its front garden. The planting of front hedgerows would augment the villages' Arcadian quality and soften the appearance of these modern houses.

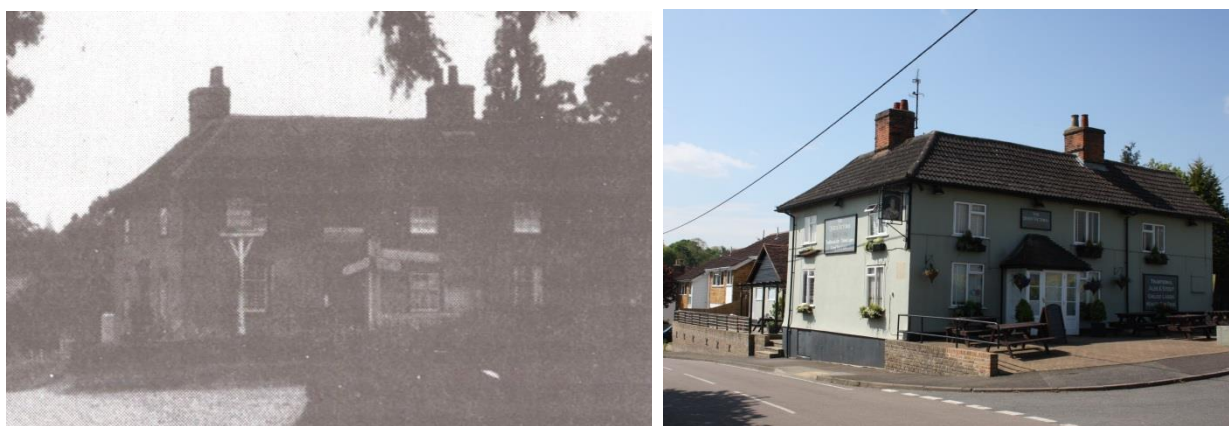
Fig. 43 The Queen Victoria PH early in the 20th century (left) and in 2016 (right)

Occupying a prominent position on the corner of the junction between the The Street and Top Road is the **Queen Victoria PH**. The timber-framed structure of this pub represents three former houses. These were part of a terrace which originally comprised six houses – one facing The Street and five facing Top Road – and was described as ‘newly built’ in 1823 (Ryan, p. 89). The Queen Victoria is mentioned in the 1861 census at which time it occupied the eastern end-house of the terrace. In the 1960s, the western three houses were demolished to make space for a car park and the pub expanded into the remaining houses.

Although the historic form of the building is still apparent, some of the 20th-century alterations detract from its traditional character. The reinstatement of timber sash windows and the use of more traditional or softer boundary treatments would hugely enhance the appearance of this prominent building. The continued use of the building contributes positively to the vitality and character of the village.

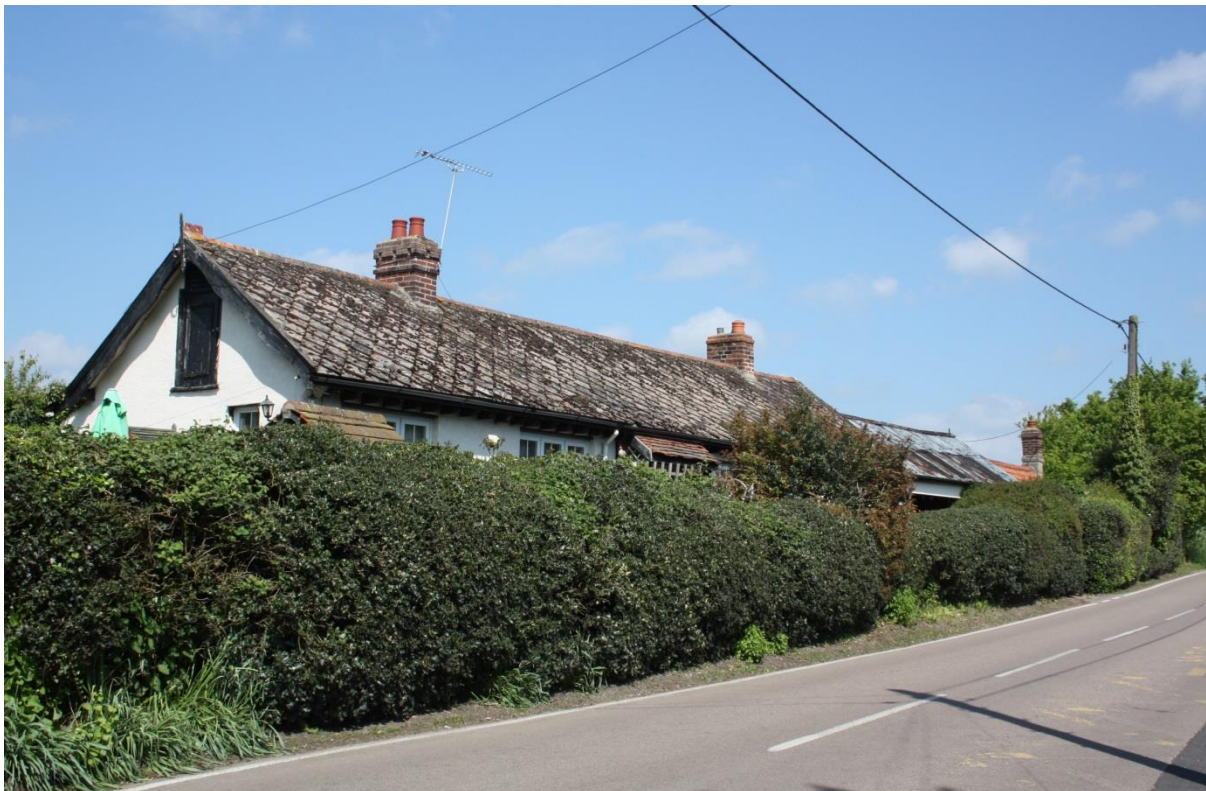
Fig. 44 Ash Cottage

Occupying a narrow roadside plot on the west side of Rectory Road is **Ash Cottage**. This is a small, single-storey cottage. Roadside cottages are a common feature of the Maldon District, with most examples dating from the late-eighteenth and early-nineteenth centuries. Ash Cottage is quite a late example since it dates from early in the 20th century. The cottage nestles into the plot, its eaves only just peeping above a mature front hedge. The building has a long, linear form with two outbuildings attached to the northern end. The roof of the main house is covered with early concrete tiles laid in a lozenge pattern, and the outbuildings are roofed with corrugated tin and Roman clay tiles.

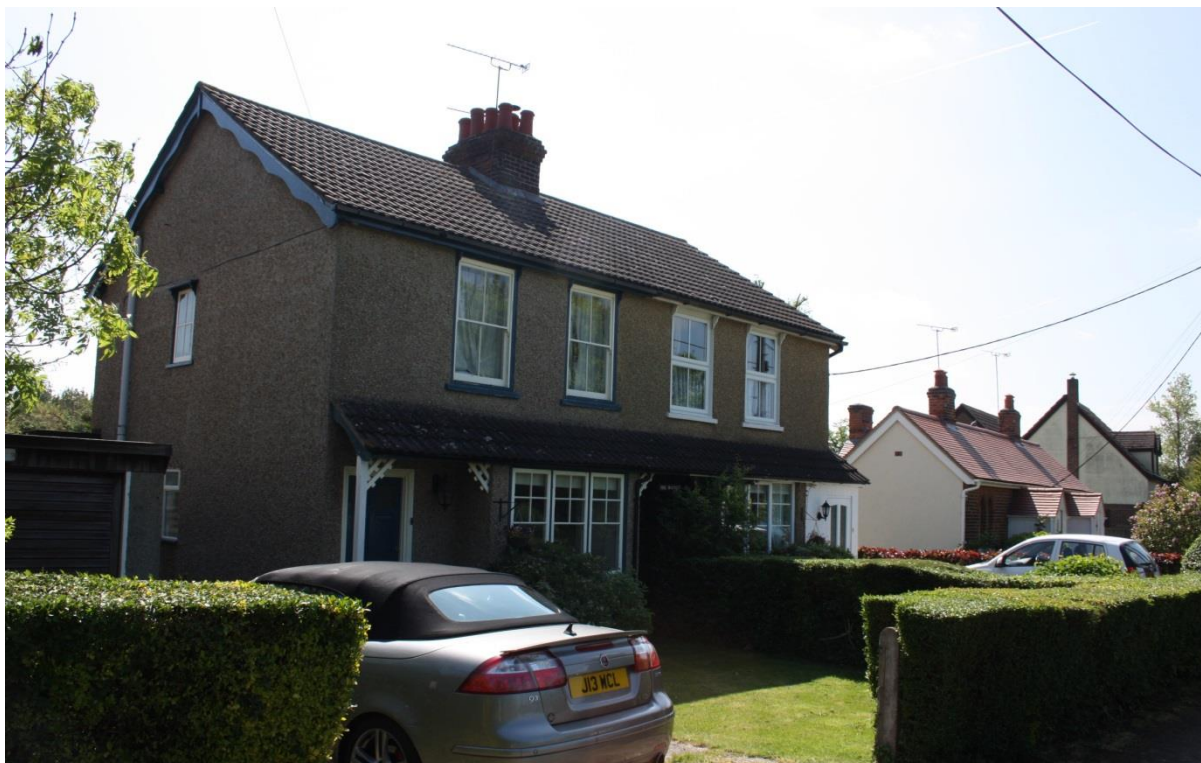
Fig. 45 2 The Maples (left) and 1 The Maples (right)

When drawing the boundary of the conservation area, it seemed logical that the northern-most properties to be included should be **1 & 2 The Maples**. Beyond this the houses are predominantly modern and of no special interest. 1 & 2 The Maples are a handsome, symmetrical pair, the essential form of which is unaltered. A particular feature is the lean-to veranda roof which is continuous across the front elevation. The pebbledash render is probably original but the concrete roof tiles are not. Both houses retain wavy-profile bargeboards in their gables.

The front elevation of No. 2 is almost perfectly preserved, retaining the original windows and curious lattice-pattern brackets to the veranda. By contrast, the façade of No. 1 has been altered by the insertion of plastic windows and by the infilling of the veranda; alterations which have eroded that property's traditional appearance. The box hedging in front of the properties is in keeping with the village's Arcadian character. The loss of the front garden of No. 1 to concrete hardstanding has resulted in a harder appearance.

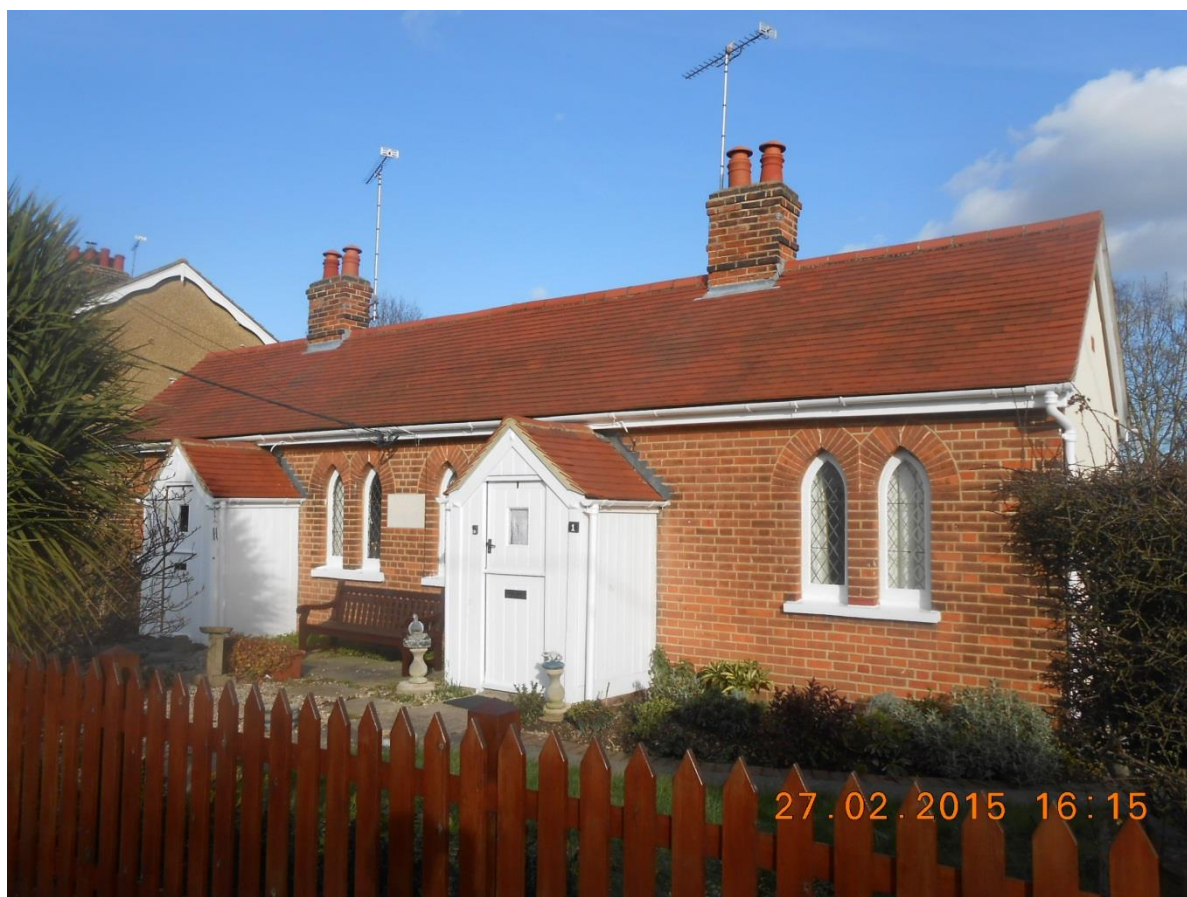
Fig. 46 1 & 2 The Almshouses

Immediately to the south of The Maples are the red brick **Almshouses**, which make a very positive contribution to the character of the conservation area. A carved stone plaque on the front reads:

The best architectural features of these tiny houses are their gothic-style windows, which have pointed-arch openings and lead-glazed panes. The porches are later, but broadly respectful of the proportions of the original building. There is a good picket fence and pretty planting along the boundary. To the rear there is a small outbuilding, possibly former privies, clad in black weatherboarding and roofed in clay tiles.
