WOODHAM WALTER

CONSERVATION AREA CHARACTER STATEMENT

This document was produced by Maldon District Council.

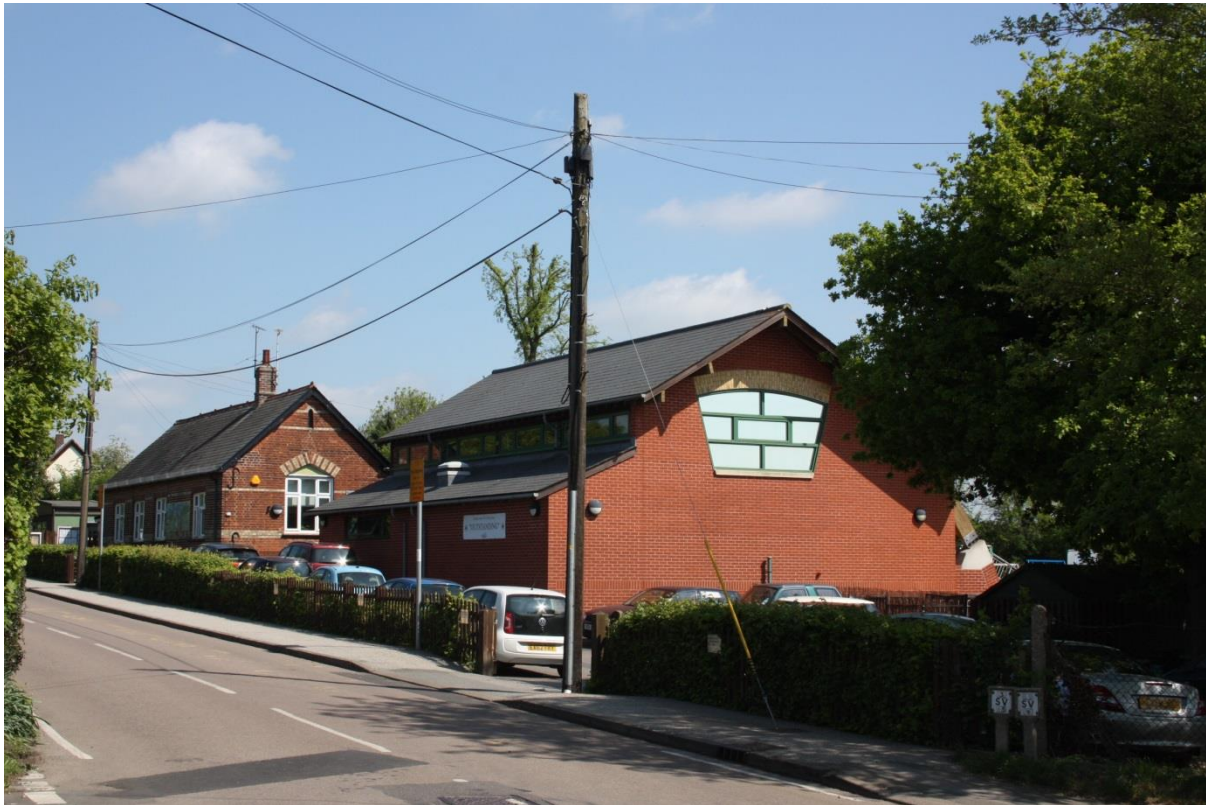
Fig. 48 Woodham Walter Primary School

A school was first built on the site of **Woodham Walter Primary School** shortly after 1829, and this was replaced by the current building in 1873 (Ryan, p. 61). The Victorian school was erected by the village builders, the Gozzetts. The original school building is a modest and fairly typical example of its type and date. But it is an important building in the context of the village. The Victorian building is built of soft red brick laid in Flemish bond with yellow / white bricks used for banding and to enliven brick arched heads. The plastic windows unfortunately dilute its Victorian character to some degree. The school features quite prominently in long views because it is sited upon the crest of the hill.

The modern extension adjacent to the road, added early this century, is a thoughtful and sensitive response to the character of the site. It employs warm, soft red bricks and slate-pitched roofs, in reference to the original school, and more contemporary-style fenestration in green-coloured frames which is quite effective.

The modern 'portakabin'-type structure at the northern end of the site, close to the road, is not attractive, but is relatively unassuming and a common and accepted feature of schools nowadays, ever under pressure to find additional space. The picket fence and box hedge front boundary is good, and successfully softens the appearance of the car park.

Some of the painted timber windows at Tadpoles Nursery (fig. 18) have arched heads in reference to the original ecclesiastical function of the building. The bay windows at the east end of The Bell and the west end of Wingtons probably relate to the former presence of shops in these parts of the properties. Casement windows with asymmetrical fanlights replaced the sash windows in the Queen Victoria pub in the 1960's, considerably eroding this building's traditional character in the process. Vertically sliding sash windows dating from the 19th and early 20th centuries are relatively common and attractive features. More unusual is the horizontally sliding sash on the front elevation of Wingtons (fig. 19). Where plastic windows have been inserted they generally fail to replicate the traditional detailing and appearance of painted timber sash windows, demonstrated by a comparison of 1&2 The Maples (fig. 20). But the modern green-finished metal windows on the extension to the school prove that contemporary-style fenestration can appear sympathetic on new buildings in historic areas (fig. 48).

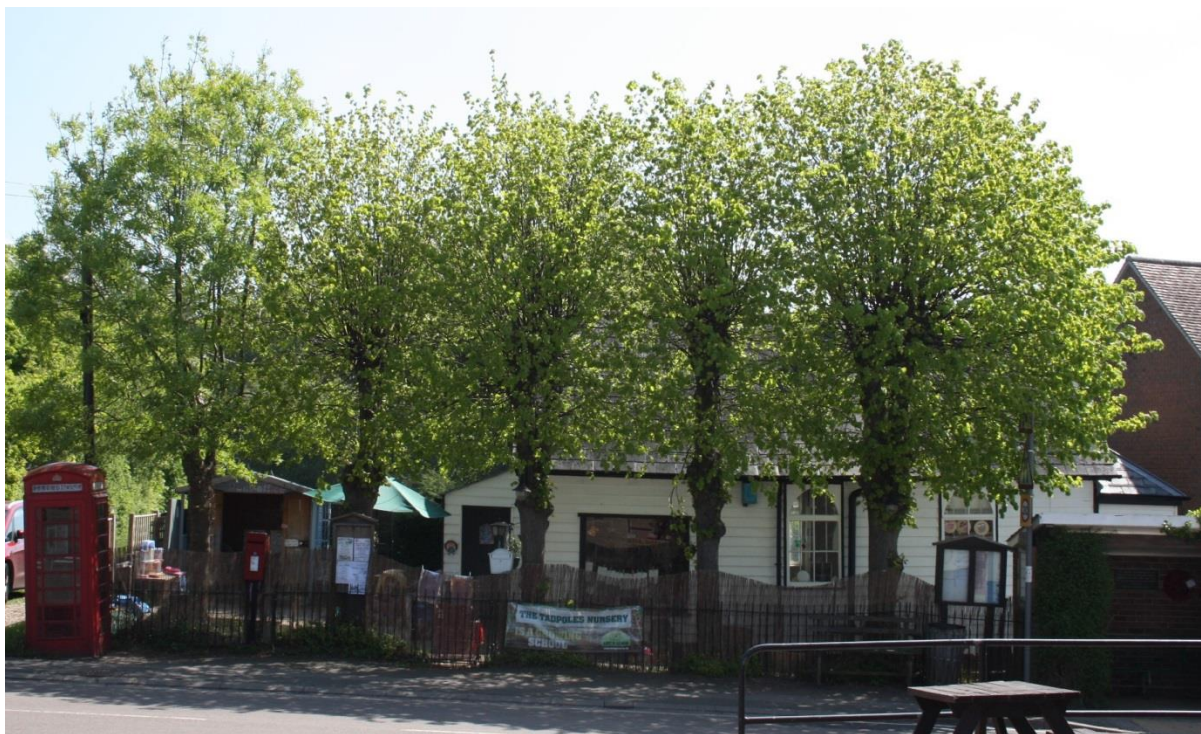
Fig. 49 Tadpoles Nursery

What is now **Tadpoles Nursery** was first built as the Congregational Chapel in 1881. Services and a Sunday School were held in the chapel until after World War II. It later became the village shop (the 'Chapel Stores'), before recently becoming Tadpoles Nursery. It is a charmingly vernacular building, clad in white-painted weatherboarding, its roof covered with natural slates. Its most memorable features are the pointed-arch timber windows, which are the only external sign of the building's formerly ecclesiastical function. The building is now partially hidden behind a row of trees, which are in themselves a pleasant feature in the street scene.

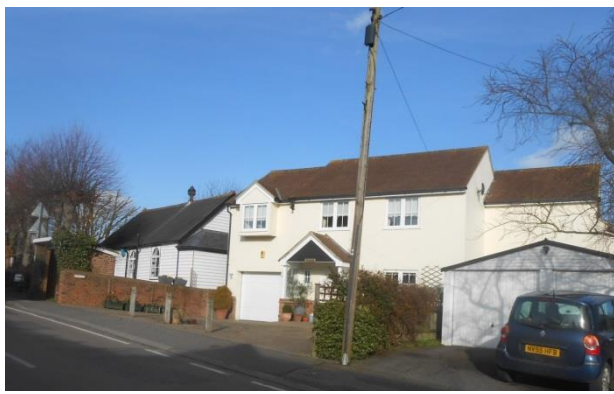
Fig. 50 Ashputtle

Ashputtle was built around 10 years ago, replacing a bungalow of the same name. The bungalow – a red brick structure with lead-glazed windows – was originally built shortly after the First World War as a village reading room. The new house is of a loosely traditional form, and makes a neutral contribution to the character of the village.

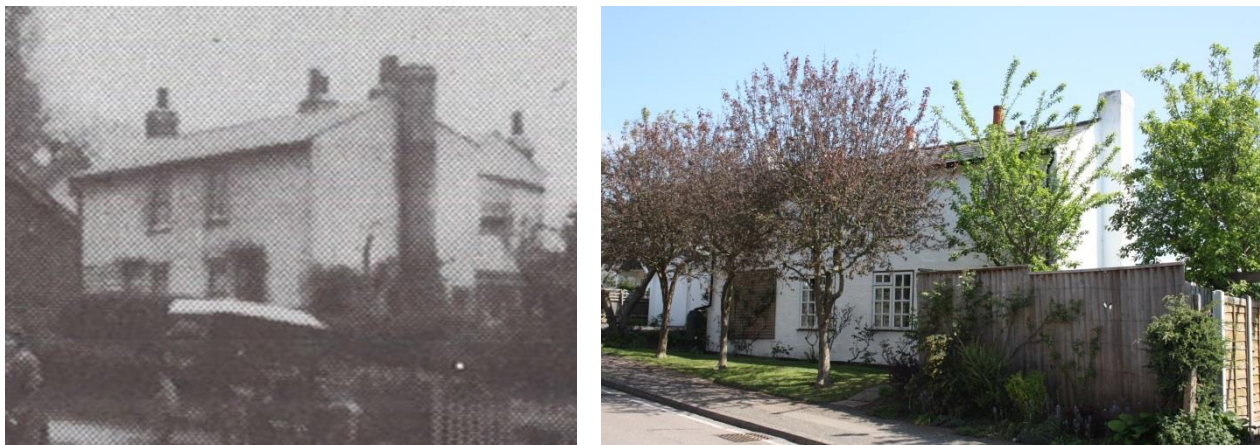
Fig. 51 Severn House early in the 20th century (left) and in 2016 (right)

To the south of Ashputtle is **Severn House** which was built in the mid-19th century as a timber-framed pair of semi-detached cottages. The cottages were converted to a single dwelling in the 1960s. The basic form of the building remains unchanged but there have been a number of modernisations. The sash windows have been replaced with timber casements which have top-opening fanlights and (by traditional standards) quite chunky detailing. A roughcast render has been applied over the building, including over the brickwork of the chimney stacks. The trees in the front garden are quite attractive.

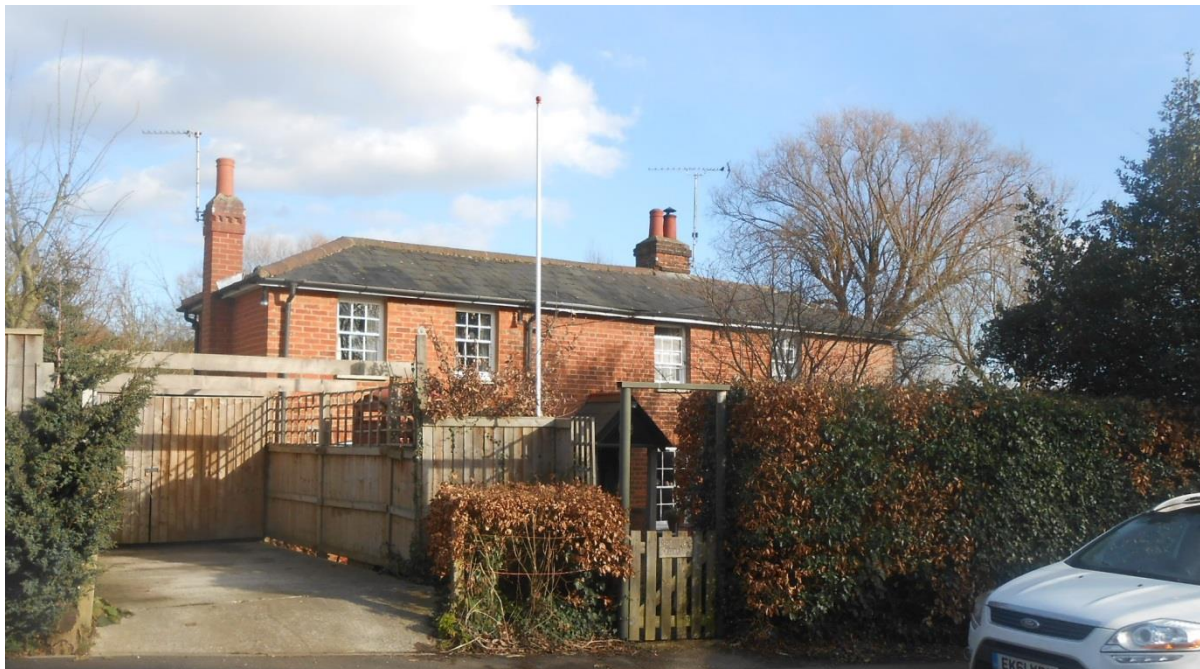
Fig. 52 2 Brick Cottages (left) and 1 Brick Cottages (right)

Redbrick Cottages are another pair of mid-19th century cottages, this time of red brick with a hipped slate roof. In the late 1980s No. 1 was extended to the side in a matching style to the original. The front elevation of the cottages, including the modern side extension to No. 1, retains fine painted-timber sash windows. At the time of the survey for this appraisal the front hedge had grown to the point that it largely conceals the front elevation from view, which is a shame since the cottages make a valuable contribution to the traditional character of the village.

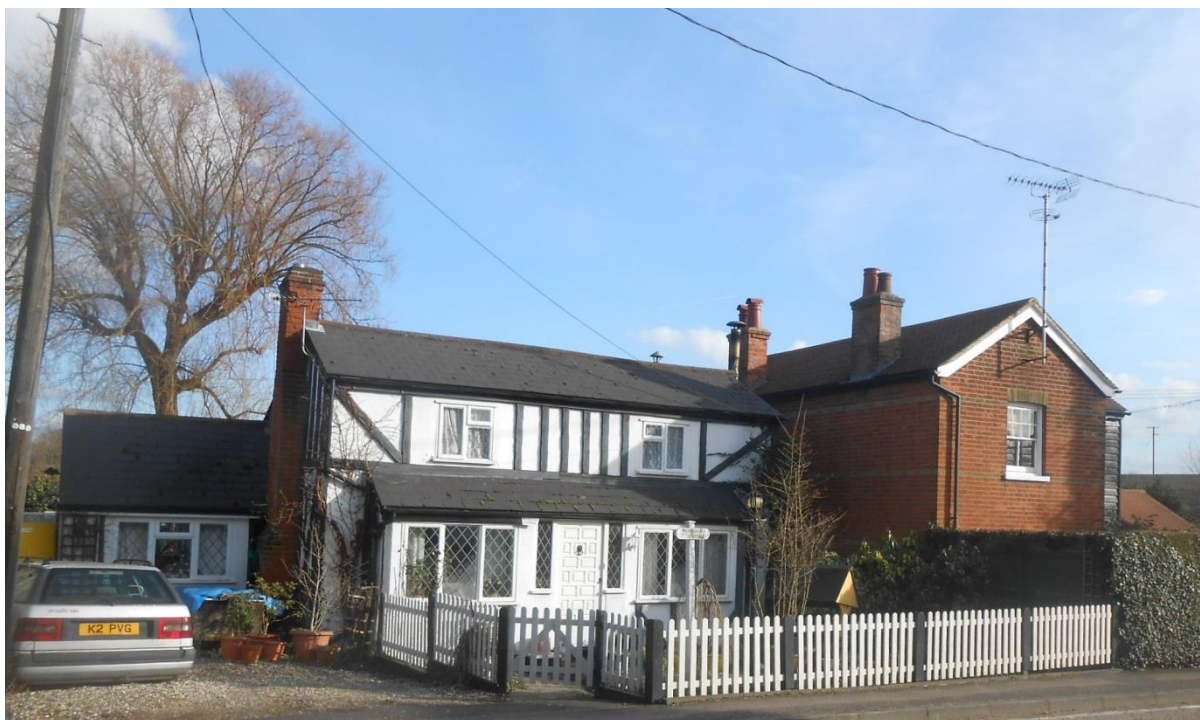
Fig. 53 Wendover Cottage (left) and Ferndale (right)

Wendover Cottage is a 19th-century house which has been ‘Tudorised’ in a playful manner in the mid-twentieth century, through the introduction of lead-glazed windows and black-painted battens to convey the impression of exposed timber-framing. The front picket fence has even been painted black and white to reflect the half-timbered effect of the house. The 19th-century form of the house is otherwise essentially little altered, retaining slate roofs and a gable-end brick chimney stack. Although the ‘Tudorised’ features are inoffensive, the restoration of the building’s Victorian character would represent an enhancement.

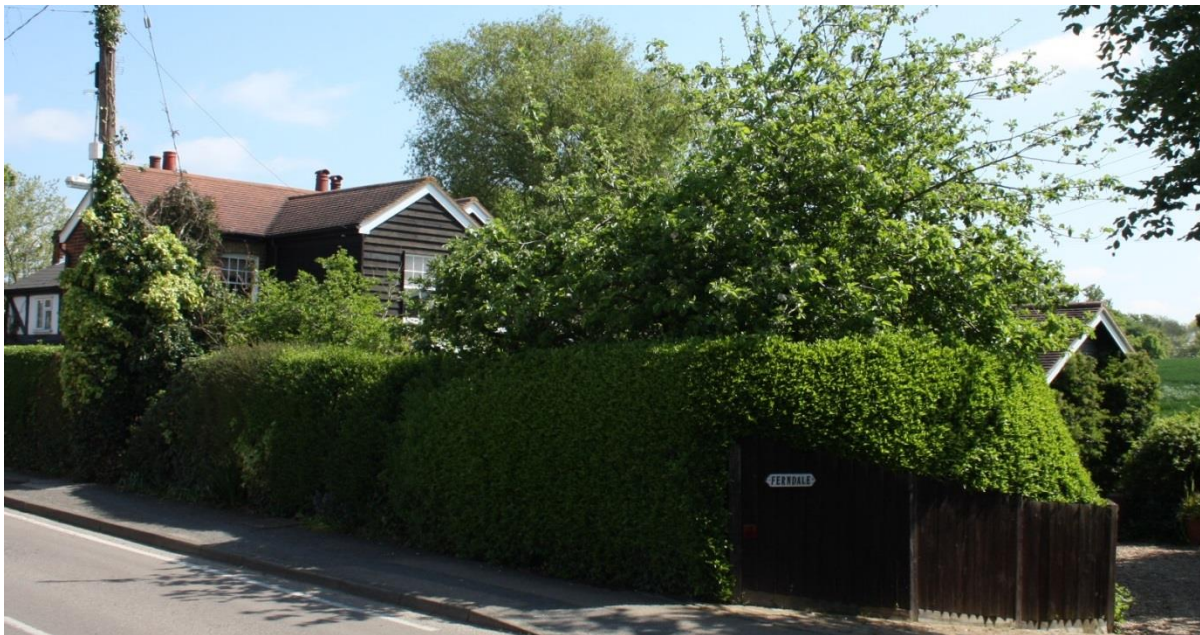
Fig. 54 Ferndale

The gabled front of **Ferndale** provides a visual stop to the housing on this side of the street. It is a late 19th-century brick house, orientated with a gable facing the road. Like the school it is predominantly of red brick but deploys some horizontal bands of yellow brick. The property was quite extensively altered in the 1990s but, due to the way in which the land slopes down from the road and the presence of a mature front hedge, the extensions are not that noticeable, and the historic building remains the most prominent element in views from the street.

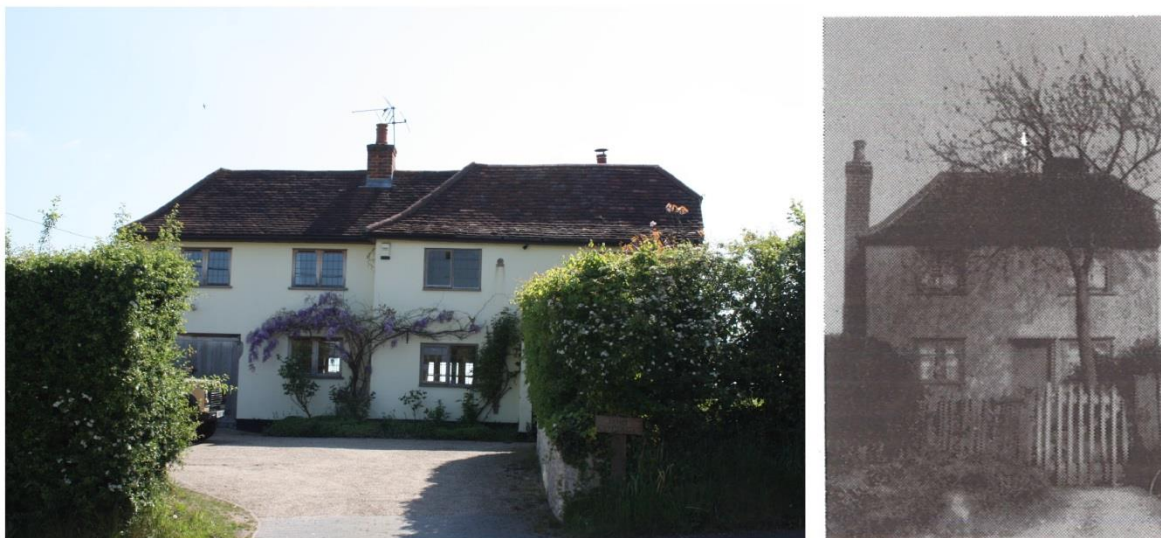
Fig. 55 Fort Cottage

Somewhat isolated on the eastern side of Church Hill, and perched on elevated land overlooking the junction with Little Baddow Road is **Fort Cottage**. It is probably Georgian in date but possibly earlier. It is known to have been occupied by two families in the mid-19th century (Ryan, p. 86). A two-storey extension was built on the north side of the cottage earlier this century. Prior to that, the two-storey front range was covered by a roof that is fully hipped to the north and half hipped to the south. The cottage has been extensively altered but in a manner which respects the spirit of the original, using hipped clay tile roofs and oak-framed and lead-glazed windows. The roof of the side extension is set back so that the form of the earlier roof can still be seen and appreciated.
